CONDITION EVALUATION AND LOAD RATING REPORT 2014

CITY OF MILL CITY

HISTORIC PEDESTRIAN RAILROAD BRIDGE

FIELD NOTES

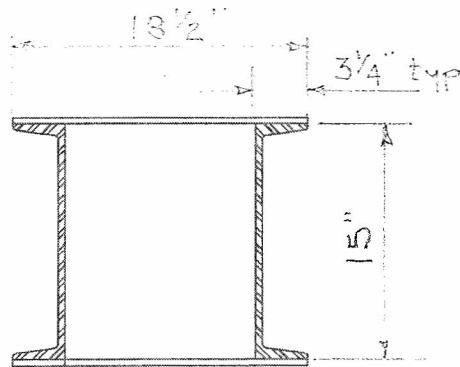
Channel webs stamped
 "ILLINOIS USA-S"
 Some show minor
 corrosion

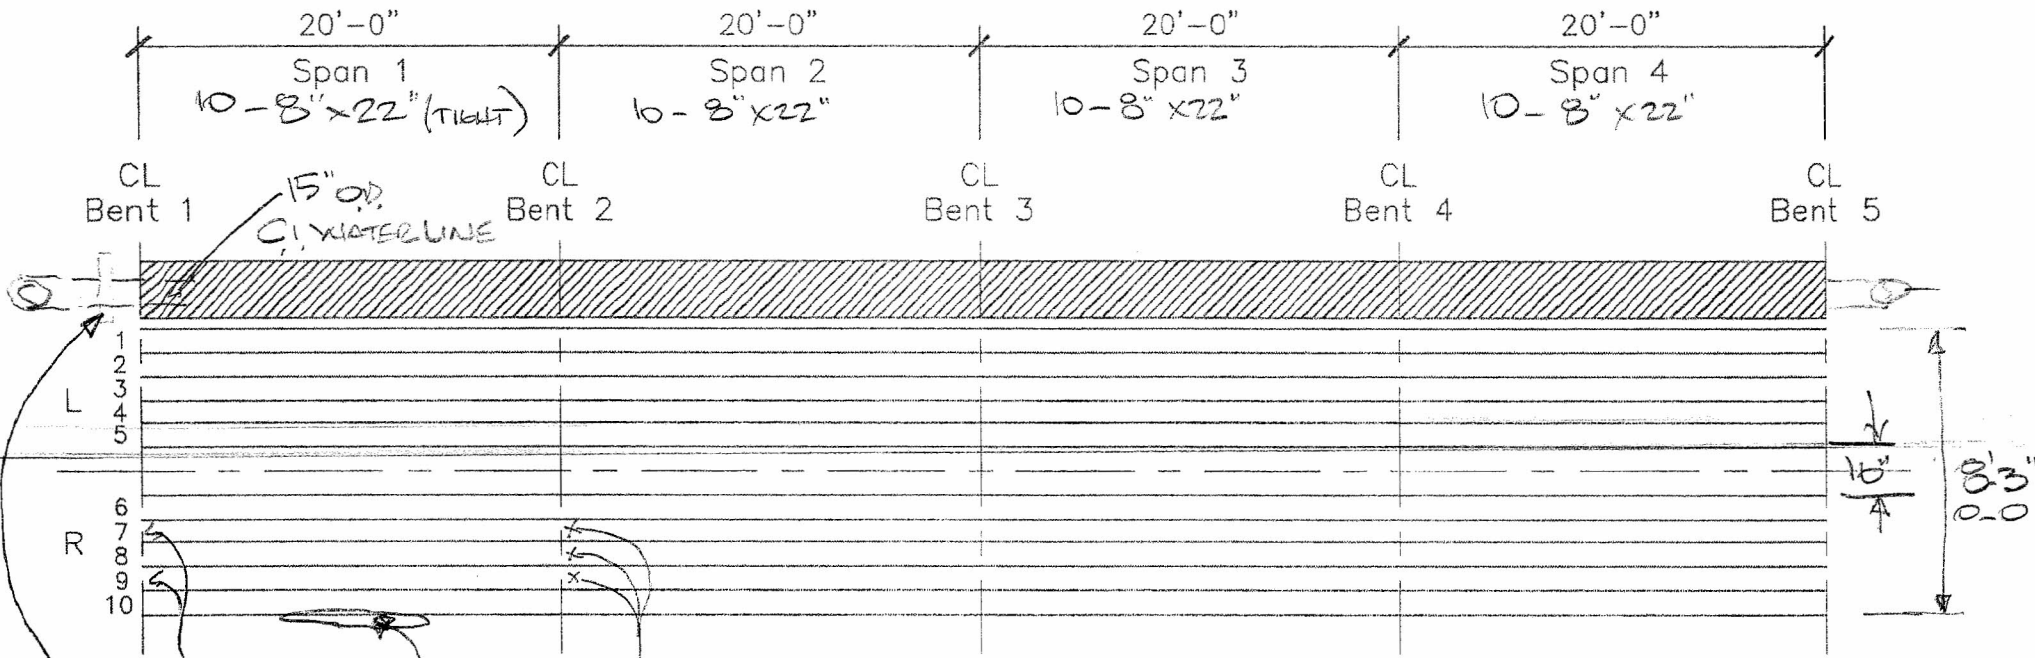
Drilled "X"

Drilled 7, 8, 9 - All X
(WET ON UNDERSIDE)

FOUND OLDER TERMITE DAMAGE.

FOUND DECAYED LAGGING
BEHIND BACKWALL @ W/L

NOTE! EXT. BEAMS 1-10 APPEAR TO BE
REUSED W/ EXTRA BOLT HOLES, TYPICAL - ALL SPANS.

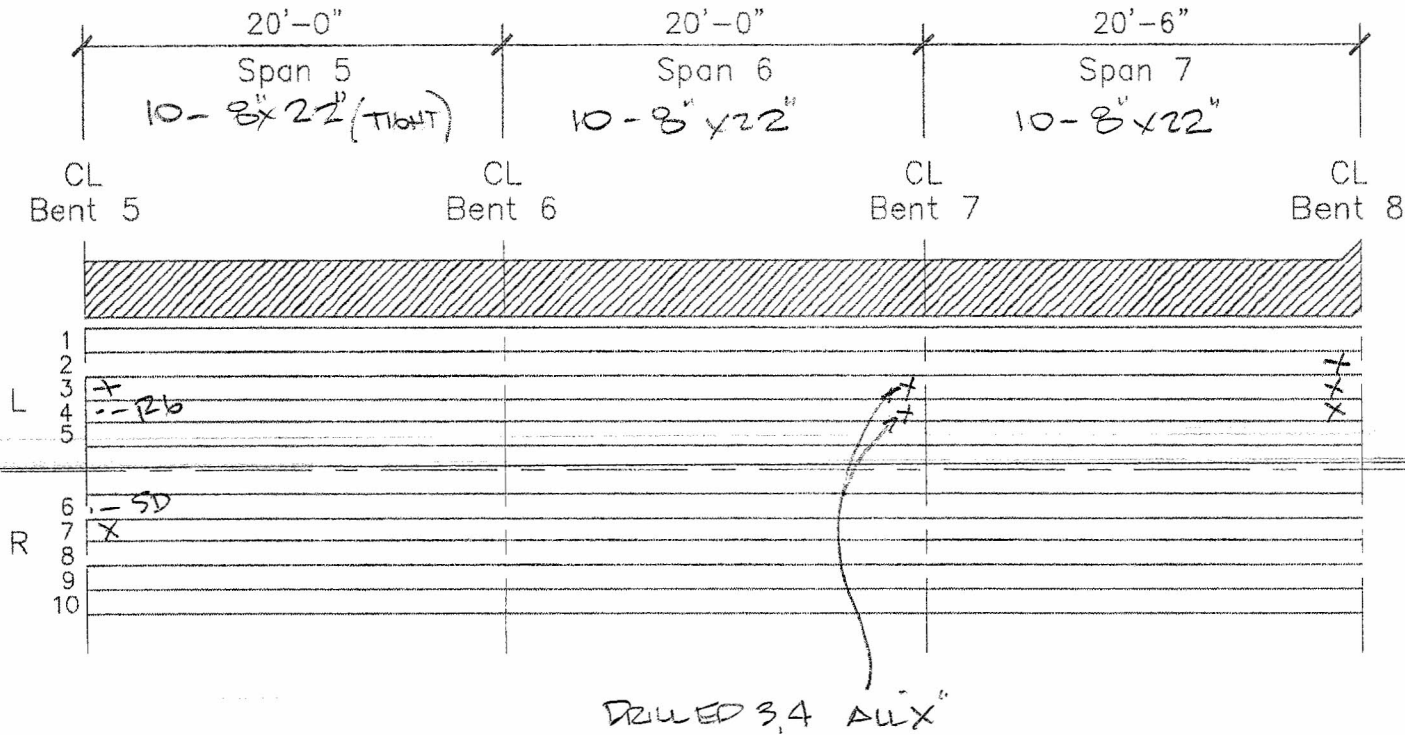
DECK PLANKS WERE REMOVED WHERE SUSPICIOUS
CONDITIONS EXISTED, REMOVED AND REPLACED
BY CITY MAINTENANCE FORCES.

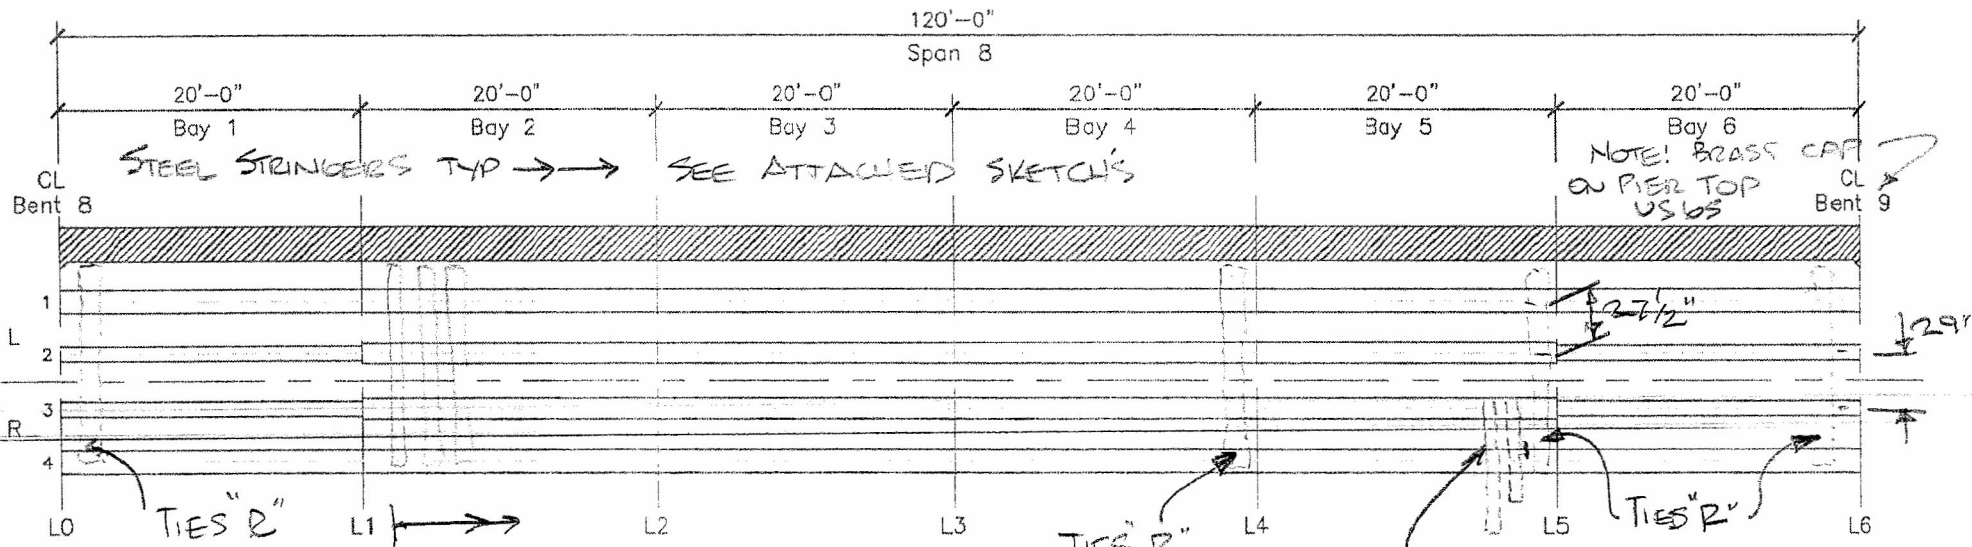
NOTE: TIES ARE GENERALLY DRIER AND SOMEWHAT
 BETTER CONDITION THAN APPROACH SPAN TIES
 HOWEVER STILL DECAYED IN TOPS @ L0, L4, L5, L6,

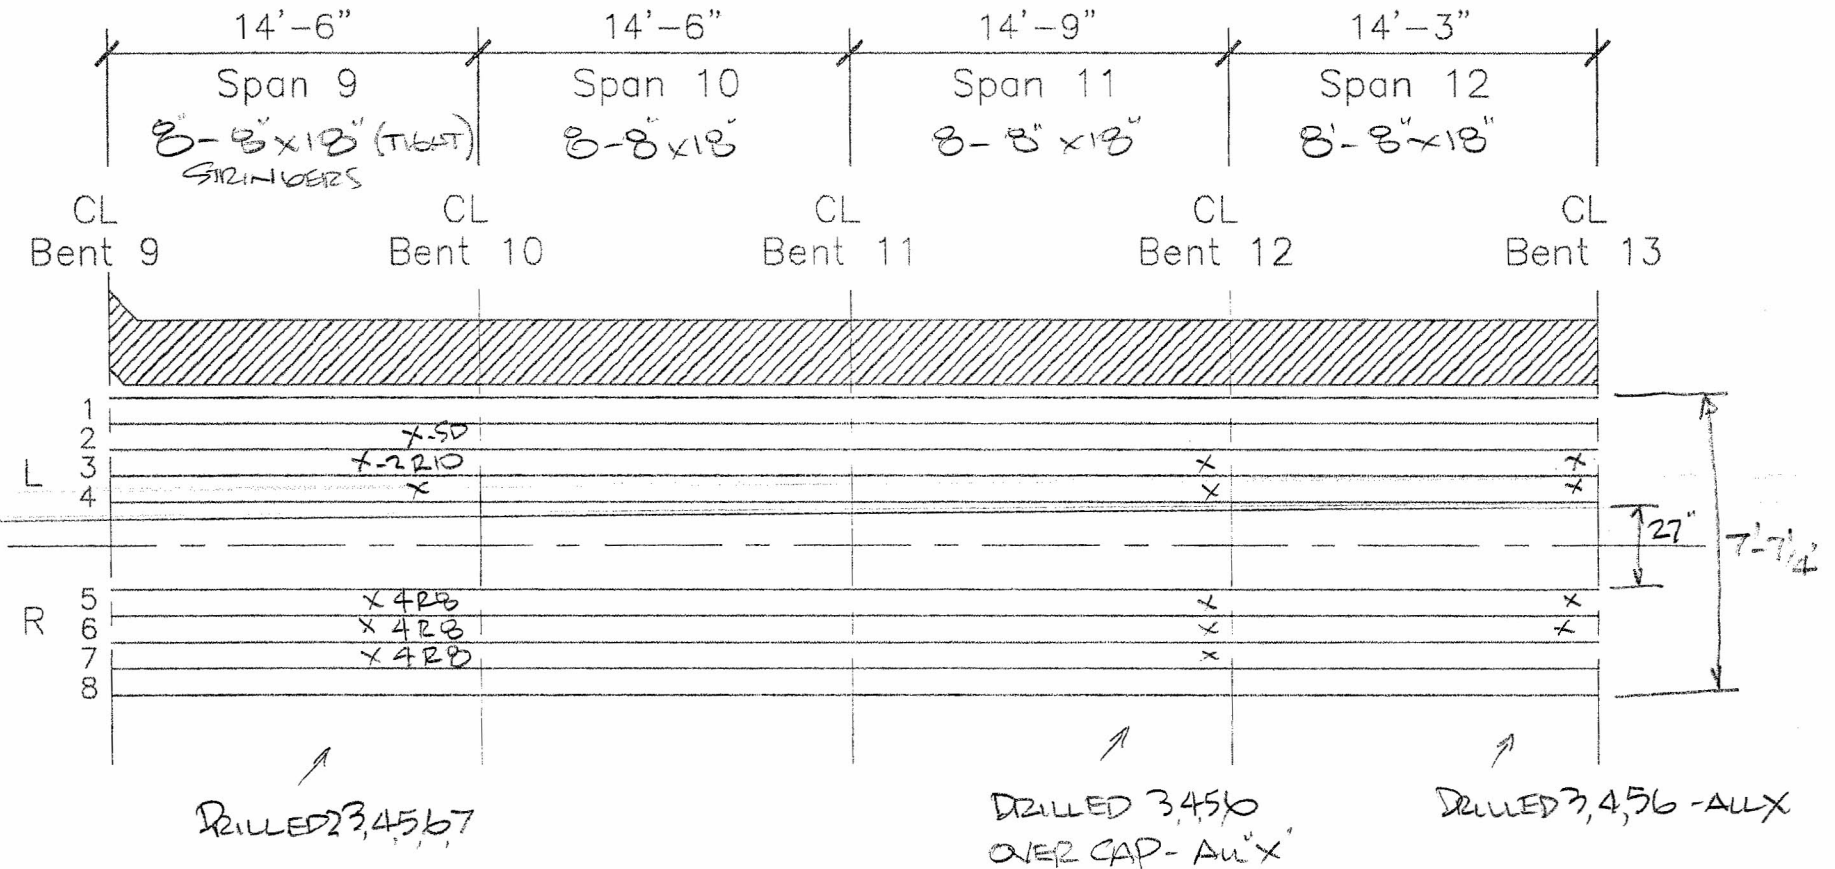
- #2 OK - STARTING DECAY WITHIN
- 3 2" X - 10" ROTTEN
- 4 DRILLED OK
- 5 4" X - 8" + ROTTEN
- 6 4" X - 8" + ROTTEN
- 7 X-4" - 8" + ROTTEN

NOTE: FOUND TIES TO BE SOFT AND DECAYING IN "TOPS" TYPICAL.

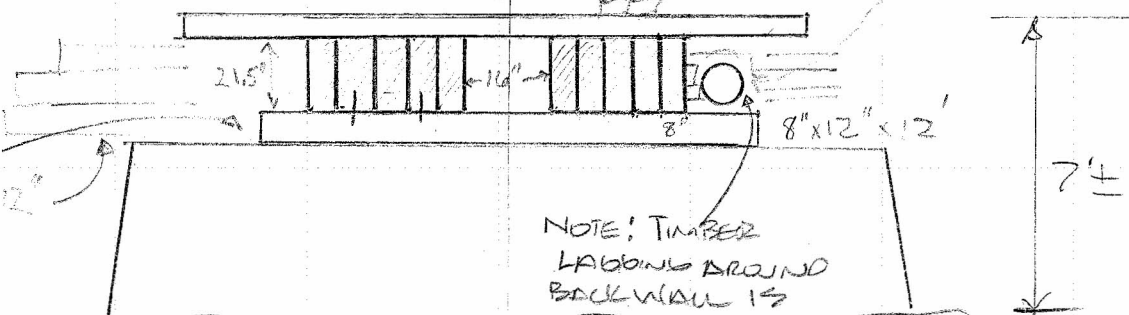
BENT 1 - SOUTH END (LOOKING BACK)

NOTE: TIMBER LAGGING AROUND BACK WALL IS

RETAINED - ALLOWING FUEL TO SPILL THROUGH

TIMBER WINDOW WALLS

ARE IN POOR CONDITION

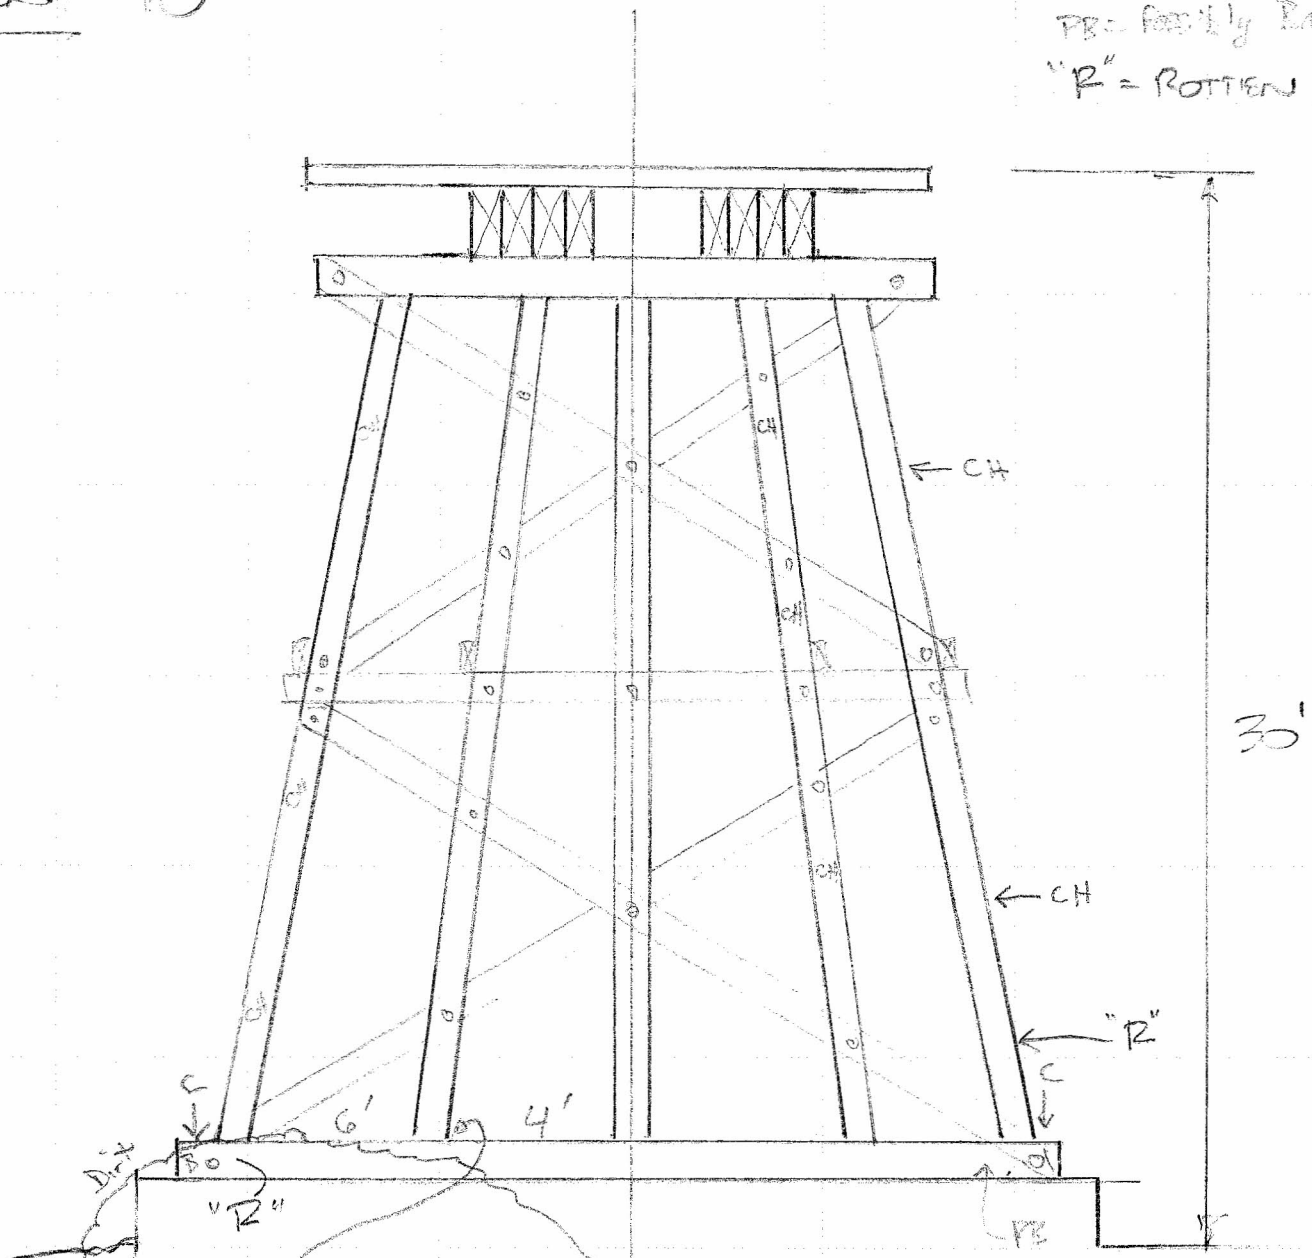
Bent 6

NOTE: POSTS ARE WEDGED TIGHT WITH CEDAR SHIMMLES UP TO 1/2" THICK.

REPLACE 12" x 14" x 24' LONG Sill

REPLACE Posts = 145 (3) 12" x 14" x 24' LONG.
