Modified Hazardous Materials Corridor Study Mill City Pedestrian Bridge

Key #21457

Linn County Road Department Mill City, Oregon July 2019

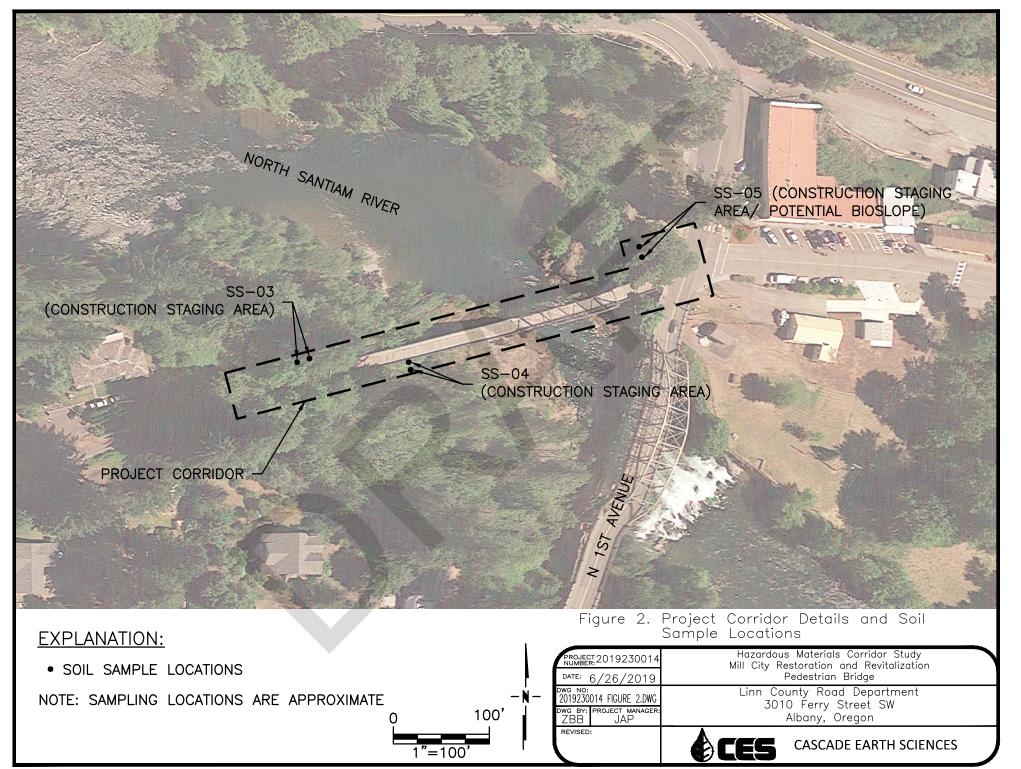
As part of the modified HMCS, CES completed surface and subsurface sampling activities in the Project Corridor. CES follows the industry standard field practices for soil sampling. Samples were analyzed by Eurofins TestAmerica, Inc., Seattle, Washington. CES personnel collecting samples are certified Occupational Safety and Health (OSHA) Hazardous Waste Operations and Emergency Response (HAZWOPER)-trained (29 Code of Federal Regulations 1910.120(e)). The approximate locations of the soil samples are shown on Figure 2.

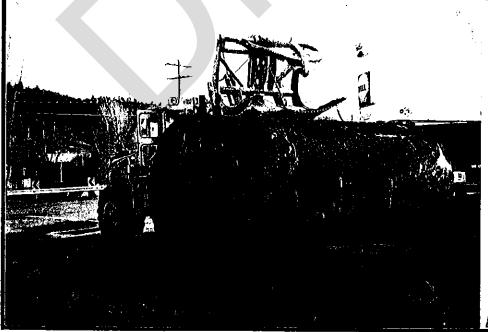
Photo 891208-02 Site Location: South side of S.W. 1st Avenue Direction Faced: South Showing: Tank #1

Photo 891208-07 Site Location: North side of service station building Direction Faced: Northeast Showing: Tank #1 after removal

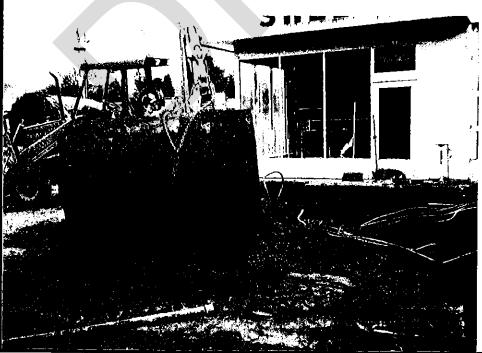
Photo 891208-3A Site Location: North side of service station building Direction Faced: Southwest Showing: Tank #4 (waste oil tank), and overfill contamination

Photo 891208-5A Site Location: North side of service station building Direction Faced; Southeast Showing: Tank #4 after removal

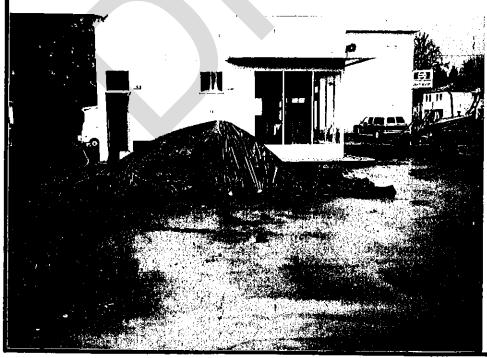
Photo 891208-12A Site Location: North side of service station building
Direction Faced: South Showing: Contaminated soils left
in place under service station building

Photo 891209-13A Site Location: East side of site

Direction Faced: West Showing: Contaminated soils covered with visqueen

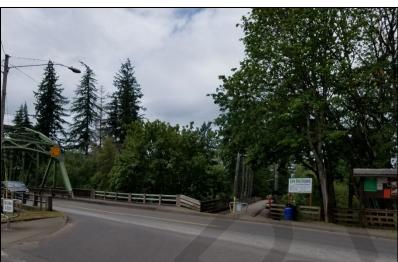
Photograph 1.

Pedestrian Bridge over the North Santiam River.

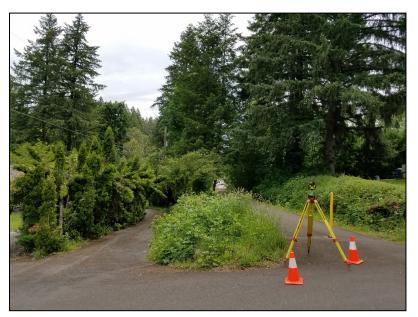
Photograph 4.

View to the northeast of the access path to the Pedestrian Bridge.

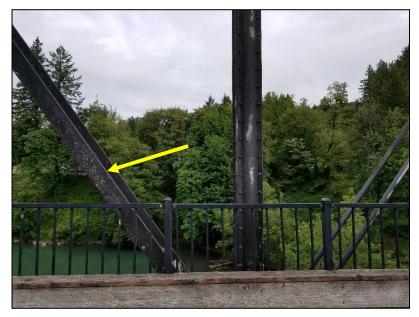
Photograph 9.

Lead-based paint sample Ped-01: Vertical supports and end diagonals.
